ARMY GROUND RISK MANAGEMENT INFORMATION

Countermeasure

MAY 2002

Half-Time REPORT

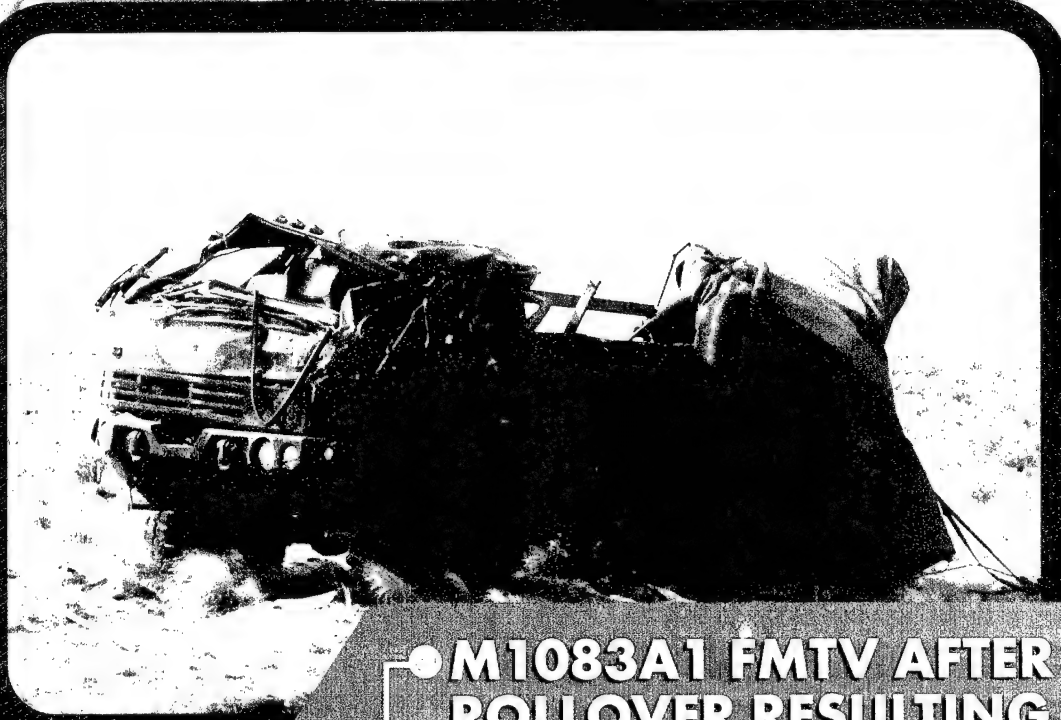
● **M1083A1 FMTV AFTER A ROLLOVER RESULTING FROM SPEED AND FAILURE TO PAY ATTENTION.**

A range detail consisting of 10 soldiers were traveling along a dirt/gravel road in an M1083A1 Family of Medium Tactical Vehicles (FMTV), when the driver lost control of the vehicle, resulting in a rollover. During the accident, one soldier was fatally injured, one soldier sustained internal injuries, and six soldiers sustained minor injuries. Damage to the vehicle was extensive.

The driver departed the range with the nine other soldiers and traveled approximately 4 kilometers when the accident occurred. Specifically, the driver failed to make a left turn at a "Y" intersection, traveled over a dirt berm between the two roads, and back onto the shoulder of the road. The driver then over-steered the vehicle in an attempt to bring the vehicle back on the road. As a result, the

vehicle rolled one time and landed back in the upright position.
